**1. Headworks leaking wall Picture #1, with electrical panels. –**

2. Headworks leaking wall Picture #2 with Insulated Hot Water Pipe. –

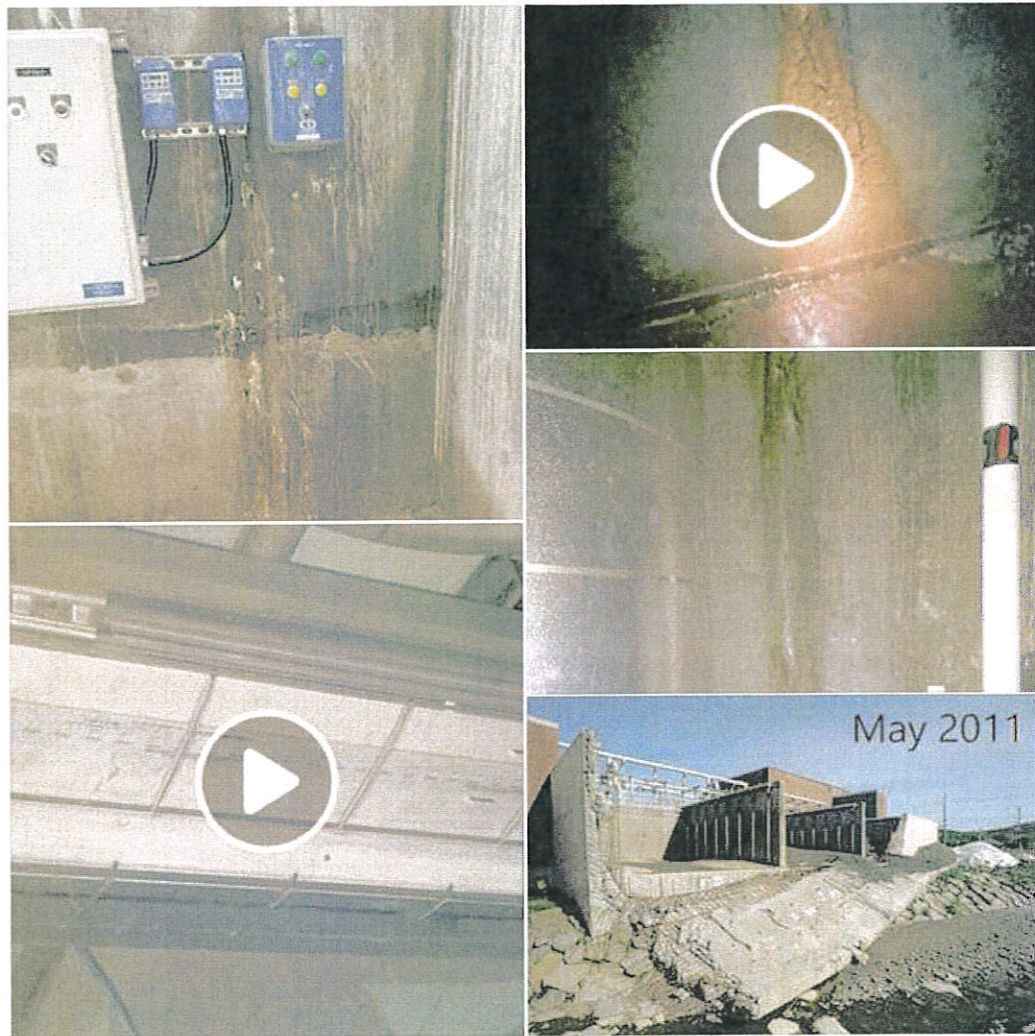
**Alleged Condition** – STP Staff alleges that the wall is leaking and is shoddy construction.

**Actual Condition** – This photo appears to be several weeks old. The headworks was put into service June 26 It does not show the completed work, and does not show that the leak has been addressed. The wall that the panels are located on backs up to the north grit channel. See attached drawing. The leak test on the channel was passed in January, 2019. All visible leaks were sealed at that time. At the time of the photograph, there are no visible leaks, just past leaks that were appropriately sealed during construction.

**Alleged Condition** – STP Staff also suggest that the control panels are covered in residue, and implying that they could be damaged.

**Actual Condition** – The issue is cosmetic, and it was addressed on the day that the picture was provided. These panels are not damaged. The streaky appearance is from water from the core drill process above the panels which ran down the wall. These panels have already been cleaned

up, and were not damaged in any way. The panels were inspected after the drilling process, and it was confirmed that the panels did not have any intrusion of water into the panels. Furthermore, the manufacturer certified the installation of the panels prior to putting the Headworks on line on June 26, 2019, and they confirmed that there were no warranty concerns.

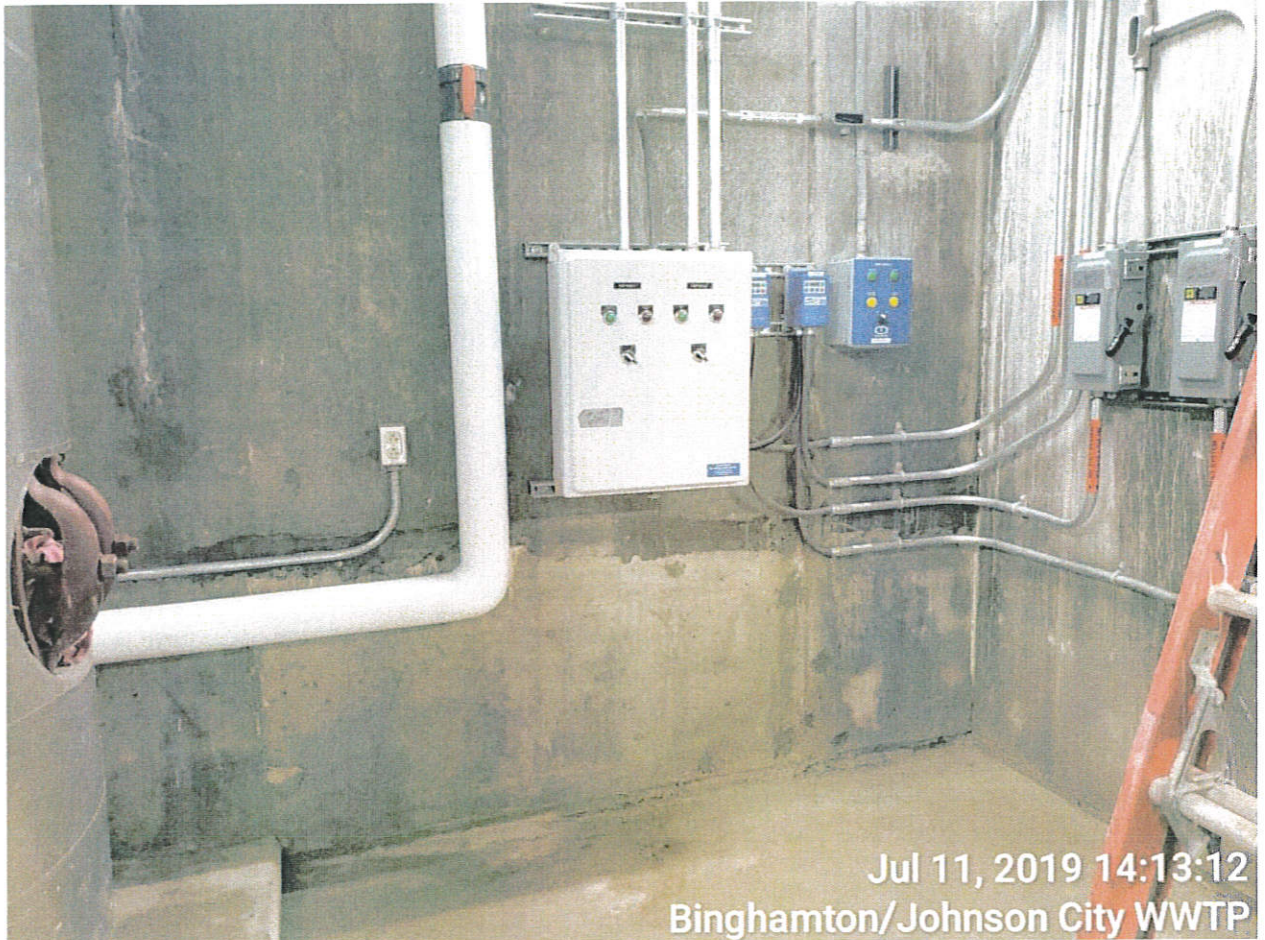
**Alleged Condition** – The text indicates that the wall is leaking and is an example of shoddy concrete work.

**Actual Condition** – This wall picture is directly adjacent to the picture in item 1. It is not more than a few feet away from the picture above. See attached photo. As we have said before, it is not uncommon for concrete to leak water after it has been cast. That is the reason that we specify that a leak test be performed for all water holding structures, and for all visible leaks to be fixed on concrete structures. There are standard commonly accepted industry practices for sealing leaks in concrete. A person knowledgeable of the industry would know about these industry accepted leak sealing products. As stated above, any leaks in the wall were sealed several weeks or even months ago. The leak in the wall could not be discovered until the leak test of the grit channel. The leak test was passed in early winter.
